Manhole Inspection Summary

Manhole # S21G1_009MH

Insp Date: **4/29/08 9:28 AM**

Location Address: **2419 banger st**

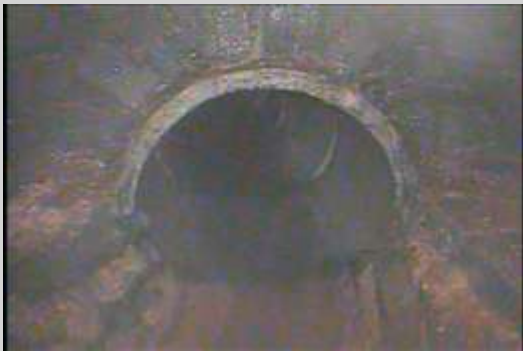
3 O'Clock Inflow

12 in. Circular Gravity Sewer
Pipe In @ 3 O'Clock

Pipe Height: **12** (in.) Rod and Bar (Angled)
Pipe Material: **Clay** ☐ Pipe Lined
Invert Depth: **19.20** (ft.) Flow Characteristics: **Fast**
Deposits: ☒ None ☐ Mud ☐ ~~Gravy~~ ☐ Debris ☐ Grease
Silt Depth: **0** (in.) Deposits Extent:
Infiltration: **None** Pipe Seal Cond: **Sound**
